True View Inspections

Inspection Report

Property Address:
340 Sample St
Covington GA 30014

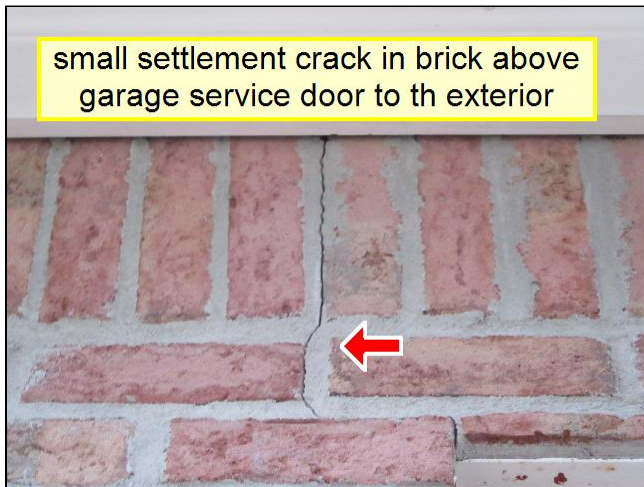
1.0 Item 1(Picture)

1.0 Small settlement crack in brick was noted above garage service door to the exterior. Repair as desired.

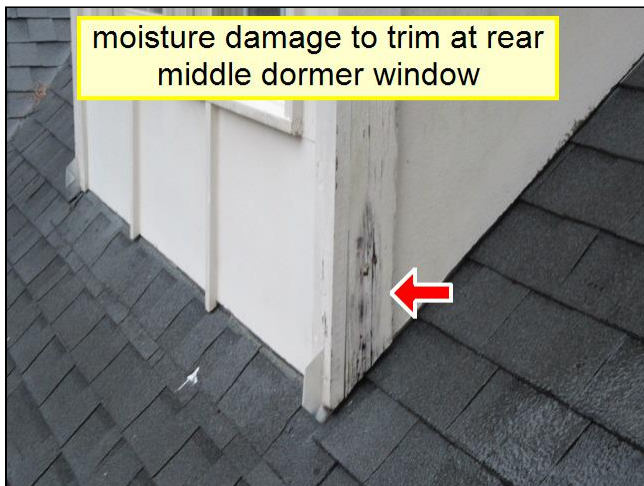
1.2 Item 1(Picture)

1.2 Moisture damage to trim was noted at corner of rear middle dormer window. Repair is needed by a qualified person.

Moisture damage to trim was noted at corner of rear middle dormer window. Repair is needed by a qualified person.

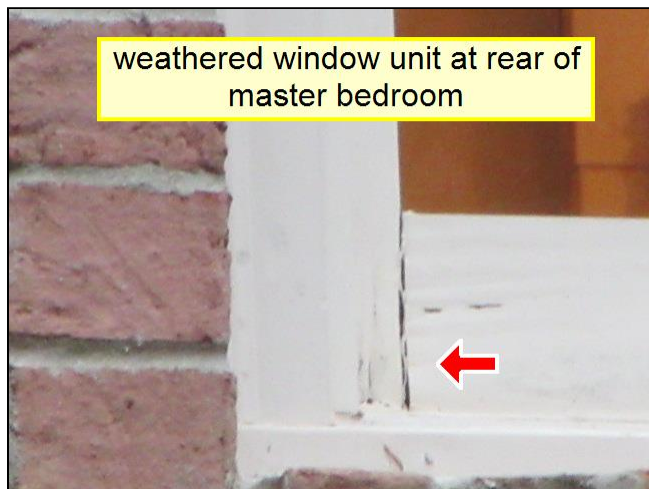
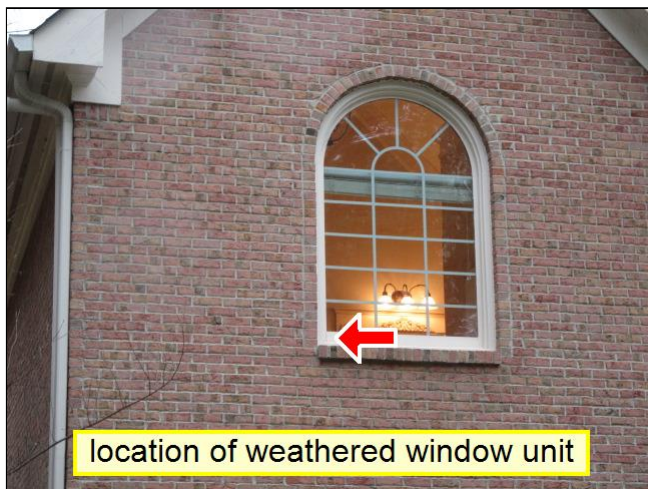
1.3 Item 1(Picture)

1.3 Missing screens were noted. Install screened as needed.

Weathered window unit was noted at rear of master bathroom. Repair is needed by a qualified person.

Missing screens were noted. Install screened as needed.

Weathered window unit was noted at rear of master bathroom. Repair is needed by a qualified person.

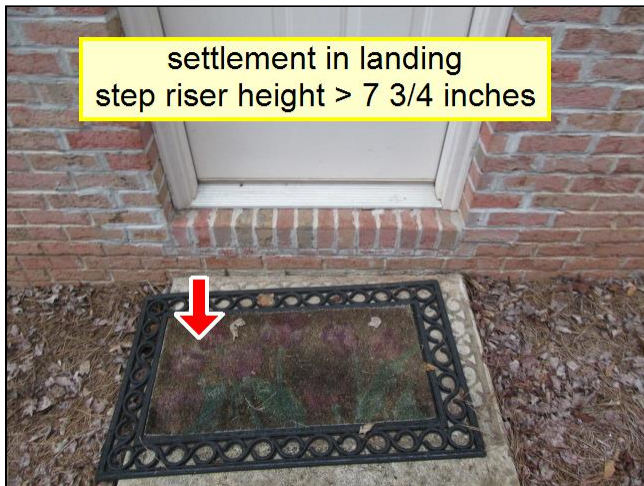
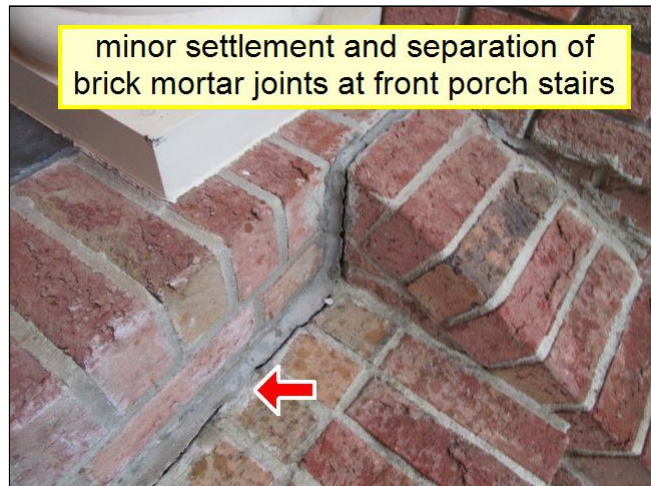
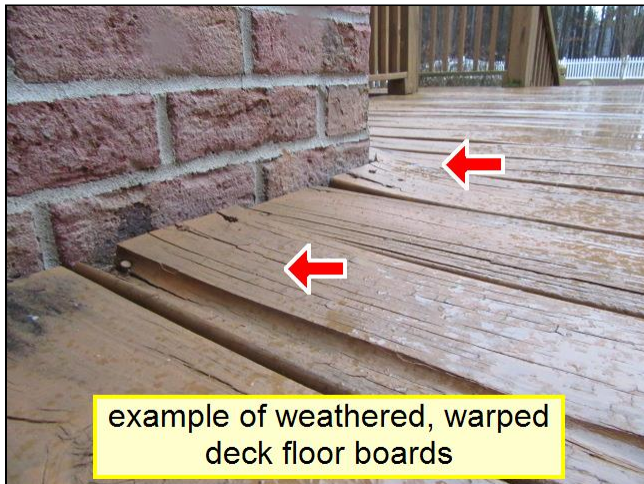
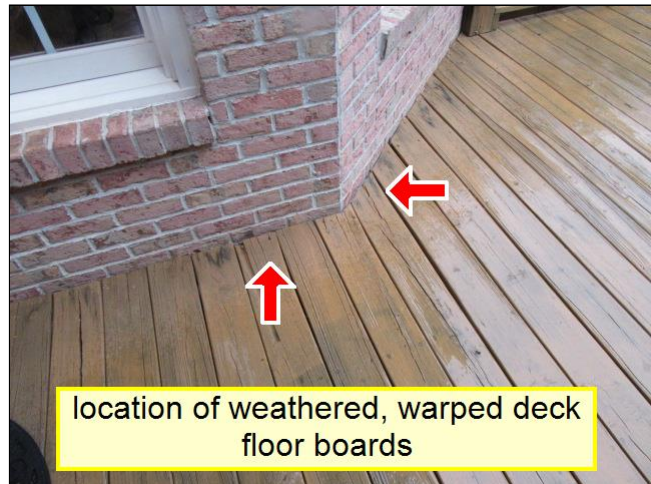
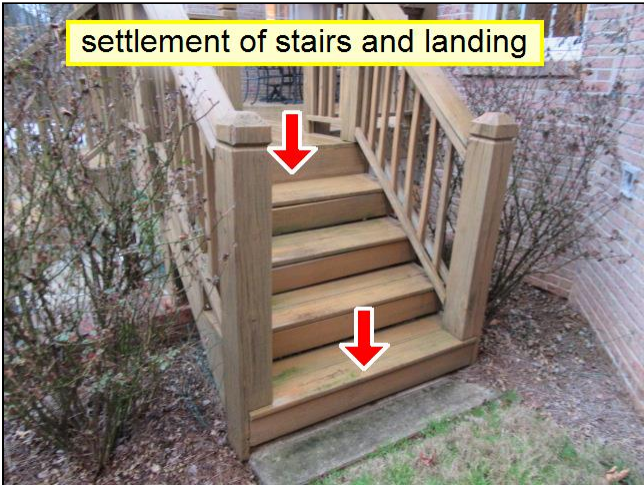
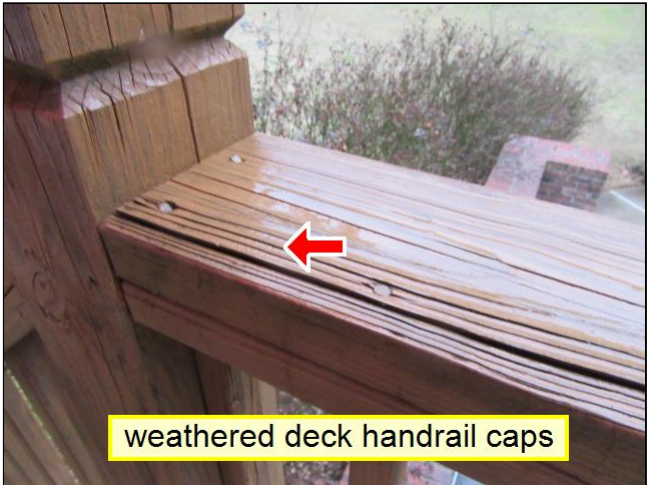
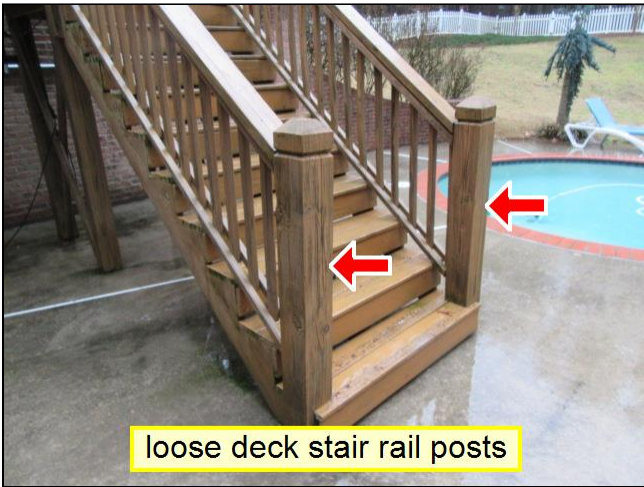
1.5 Item 1(Picture)

1.5 Settlement in landing outside outside of garage service door to the exterior was noted, which has resulted in step riser > that 7 3/4 inches. Suggest monitoring for trip hazard and correct as needed.

Minor settlement or front porch stairs and separation of brick mortar joints were noted. Suggest monitoring and re-pointing of mortar joints as needed.

No less than 3 weathered, warped deck floor boards were noted. Recommend these boards be monitored and replaced as needed.

Settlement of deck stairs and landing at left side of deck was noted. The stairs are difficult to traverse. Recommend repair by a qualified professional.

Loose deck stair rail posts were noted at bottom of rear staircase. Recommend adjustment.

Weathered deck handrail caps were noted. Suggest caps be monitored and replaced as needed.

Settlement in landing outside outside of garage service door to the exterior was noted, which has resulted in step riser > that 7 3/4 inches. Suggest monitoring for trip hazard and correct as needed.

Minor settlement or front porch stairs and separation of brick mortar joints were noted. Suggest monitoring and re-pointing of mortar joints as needed.

No less than 3 weathered, warped deck floor boards were noted. Recommend these boards be monitored and replaced as needed.

Settlement of deck stairs and landing at left side of deck was noted. The stairs are difficult to traverse. Recommend repair by a qualified professional.

Loose deck stair rail posts were noted at bottom of rear staircase. Recommend adjustment.

Weathered deck handrail caps were noted. Suggest caps be monitored and replaced as needed.

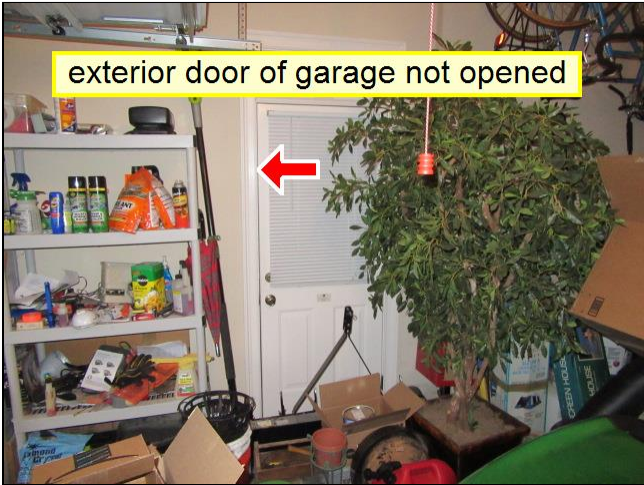
1.6 Item 1(Picture)

1.6 Exterior door of garage was obstructed by storage and not opened.

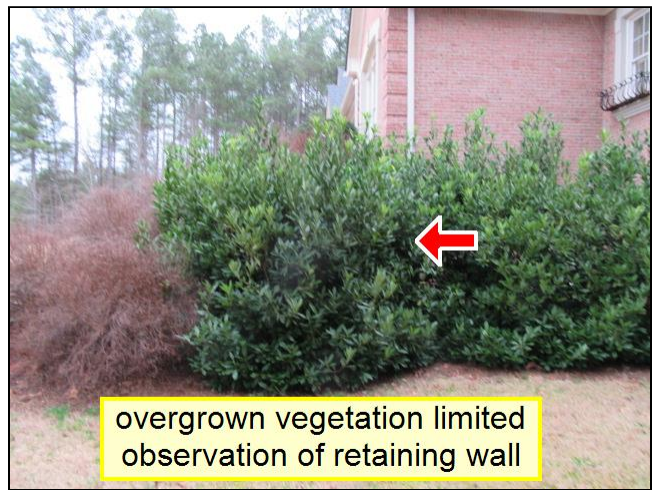
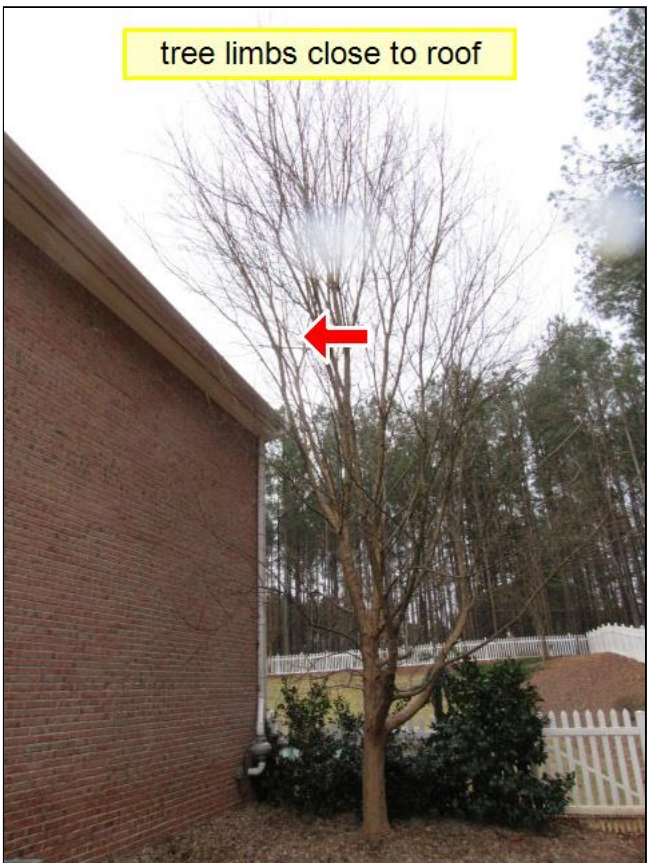
1.8 Item 1(Picture)

1.8 Overgrown vegetation around the exterior of home was noted that limited observation of exterior building elements.

Tree limbs close to home were noted. Recommend limbs be kept trimmed back to prevent easy access for squirrels.

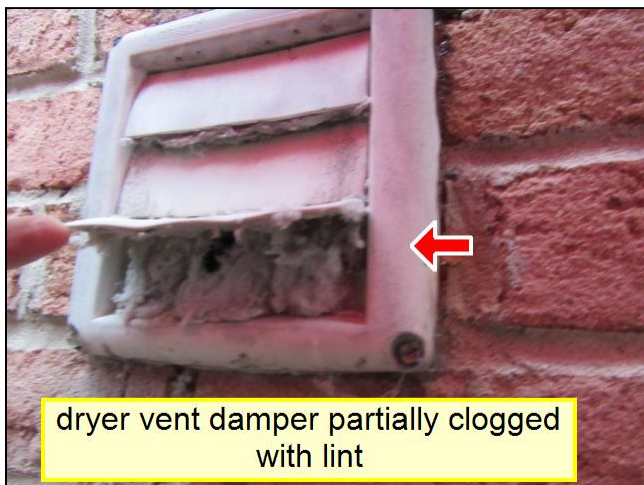
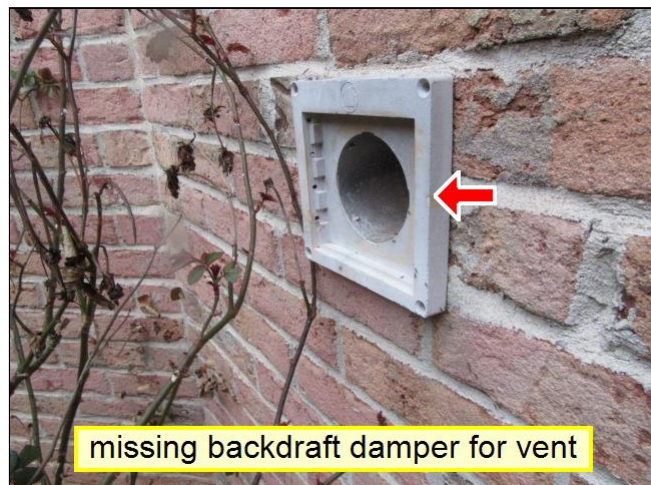
1.10 Item 1(Picture)

1.10 Dryer vent damper was partially obstructed with lint. Cleaning of dryer vent damper is needed.

Missing backdraft damper for vent was noted at back side of home. Damper should be added to prevent back drafting and easy access for pests and animals.

Missing backdraft damper for vent was noted at back side of home. Damper should be added to prevent back drafting and easy access for pests and animals.

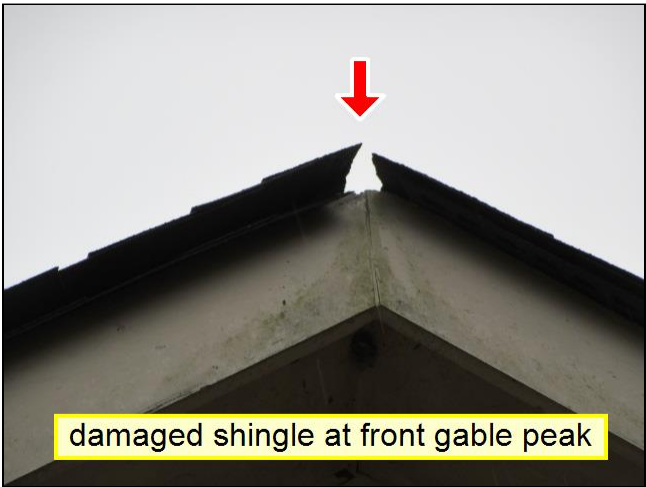
2.0 Item 1(Picture)

2.0 Damaged shingle at front right gable peak was noted. Replacement of shingle is needed.

Damaged shingle at front right gable peak was noted. Replacement of shingle is needed.

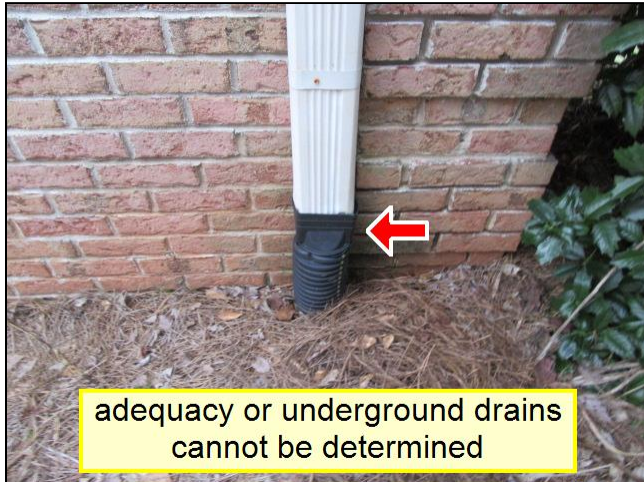
2.2 Item 1(Picture)

2.2 The adequacy of underground downspout drains cannot be determined during this visual inspection. Suggest drains be monitored and corrected as needed.

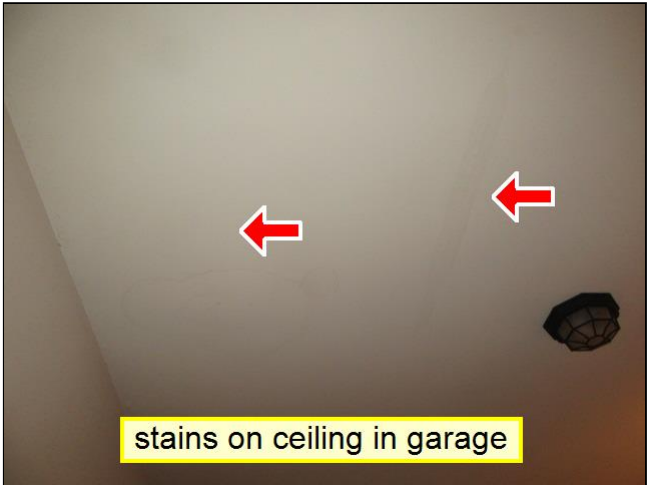
4.0 Item 1(Picture)

4.0 Stains, testing dry with a moisture meter at time of inspection, were noted on ceiling in upstairs left bedroom (tv room) and in garage. No leaks were detected at time of inspection. Stains can be eliminated by priming and re-painting. (Recommend further inquiry with the seller regarding knowledge of leak and any repairs made).

Cracks common to drywall were noted. These are usually cosmetic and may be repaired as desired, however monitoring of all cracks for possible movement is suggested. Some cracks may re-occur as a result of normal expansion and contraction from changing indoor humidity levels and seasonal changes.

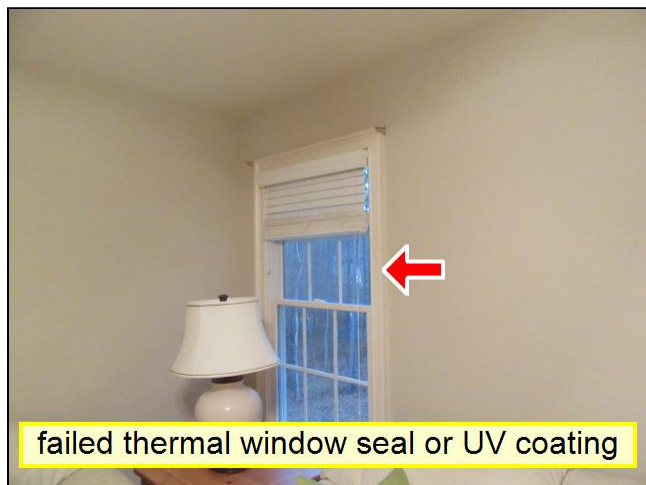
4.2 Item 1(Picture)

4.2 Determining the condition of insulated glass windows is not always possible due to temperature, weather, cleanliness of windows and lighting conditions. **Evidence of failed thermal window seals or UV coatings** were noted at the following locations: (front most window of upstairs left bedroom). This condition can only be corrected by a qualified window or glazing contractor. Recommend budgeting for eventual repair of these windows.

Determining the condition of insulated glass windows is not always possible due to temperature, weather, cleanliness of windows and lighting conditions. **Evidence of failed thermal window seals or UV coatings** were noted at the following locations: (front most window of upstairs left bedroom). This condition can only be corrected by a qualified window or glazing contractor. Recommend budgeting for eventual repair of these windows.

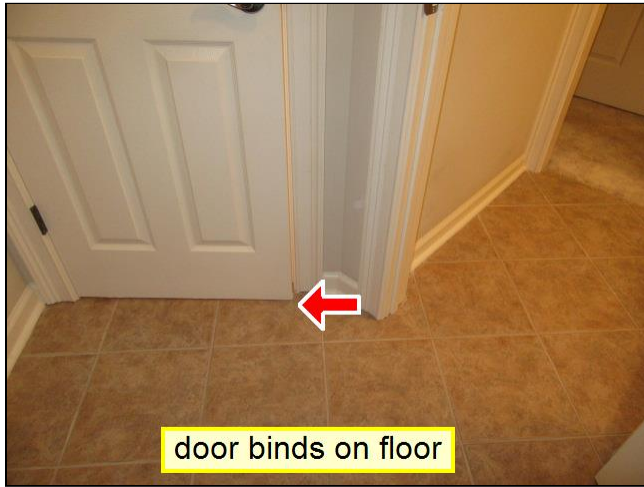
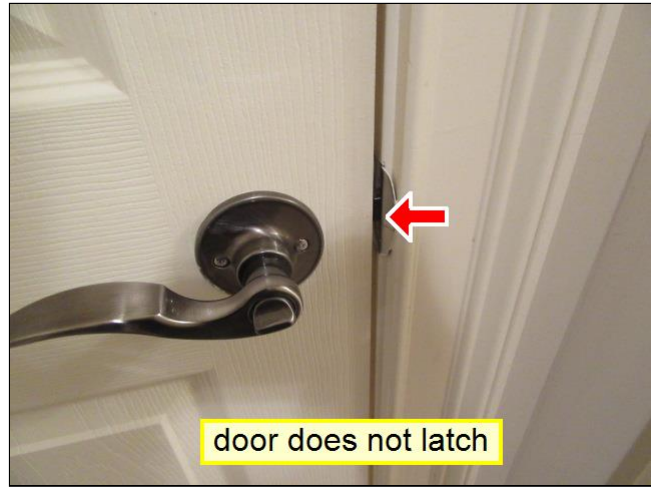
4.3 Item 1(Picture)

4.3 Door binds on tile floor in upstairs shared bath. Adjustment is needed.

Door that does not latch was noted in upstairs shared bath. Suggest adjustment.

Door that does not latch was noted in upstairs shared bath. Suggest adjustment.

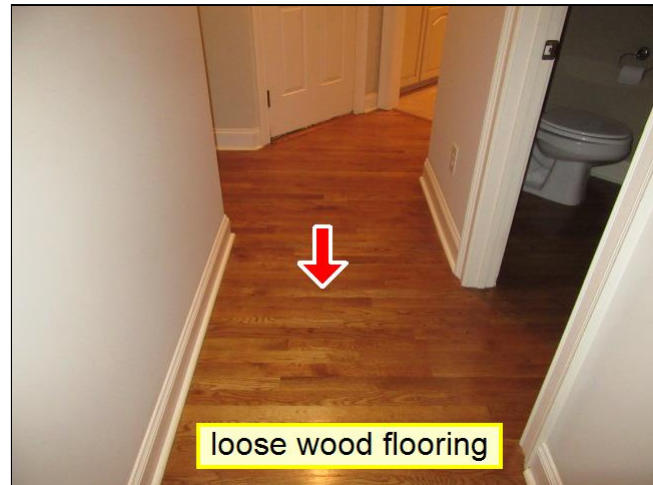
4.4 Item 1(Picture)

4.4 Floor tiles crack and pop when walked on in breakfast area. This condition indicates the tiles has lose their bond to the substrate. The remaining life expectancy of the tile floor installation cannot be determined. Advise budgeting for eventual replacement of tile floor.

Loose, squeaky wood flooring was noted in hallway between kitchen and family room. Suggest monitoring and repair as needed.

Unlevel floor in master bedroom was noted. It appears that a section of floor decking is not level with adjacent decking boards. Recommend further review and repairs as necessary by a qualified professional. (Be advised that pulling the carpet back may be necessary for a proper observation)

Floor tiles crack and pop when walked on in breakfast area. This condition indicates the tiles has lose their bond to the substrate. The remaining life expectancy of the tile floor installation cannot be determined. Advise budgeting for eventual replacement of tile floor.

Loose, squeaky wood flooring was noted in hallway between kitchen and family room. Suggest monitoring and repair as needed.

Unlevel floor in master bedroom was noted. It appears that a section of floor decking is not level with adjacent decking boards. Recommend further review and repairs as necessary by a qualified professional. (Be advised that pulling the carpet back may be necessary for a proper observation)

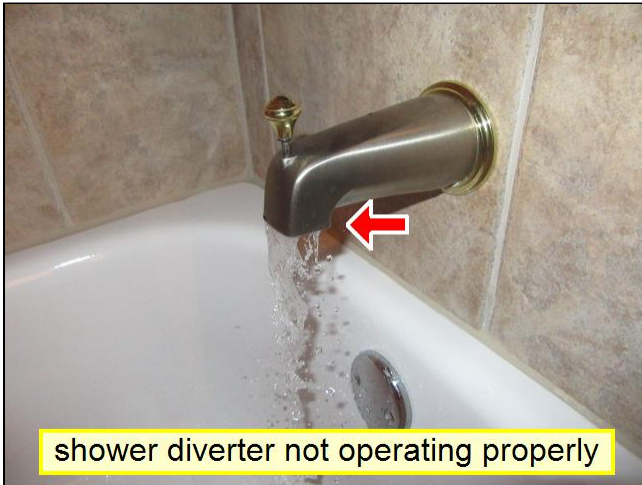
5.2 Item 1(Picture)

5.2 Shower diverter in upstairs shared bath does not divert water to shower head properly as water flows through shower head and tub spout simultaneously. Suggest monitoring and replacement of shower diverter/tub spout as needed.

Shower diverter in upstairs shared bath does not divert water to shower head properly as water flows through shower head and tub spout simultaneously. Suggest monitoring and replacement of shower diverter/tub spout as needed.

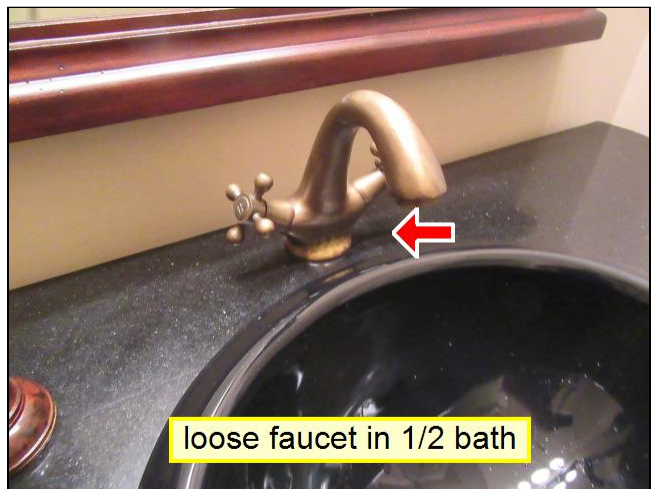
5.8 Item 1(Picture)

5.8 Loose faucet in 1/2 bath was noted. Recommend adjustment or repair.

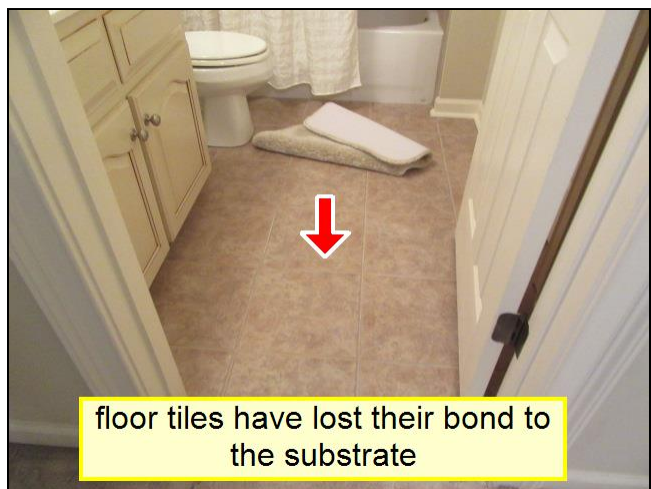
5.11 Item 1(Picture)

5.11 Floor tiles crack and pop when walked on in upstairs front bedroom bath and master bath. This condition indicates the tiles have lose their bond to the substrate. The remaining life expectancy of the tile floor installation cannot be determined. Advise budgeting for eventual replacement of tile floor.

Floor tiles crack and pop when walked on in upstairs front bedroom bath and master bath. This condition indicates the tiles have lose their bond to the substrate. The remaining life expectancy of the tile floor installation cannot be determined. Advise budgeting for eventual replacement of tile floor.

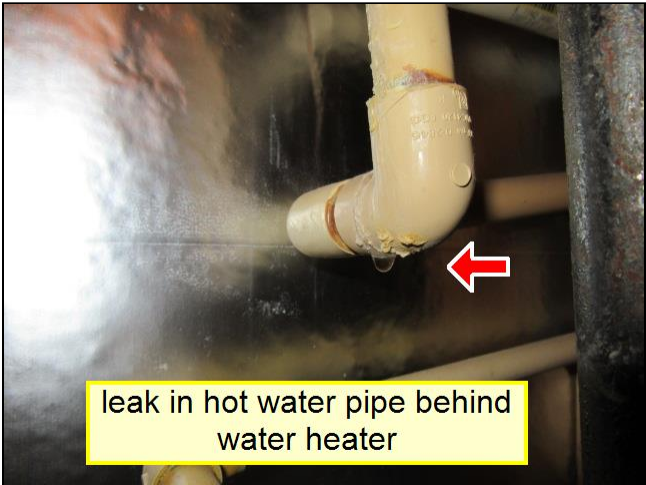
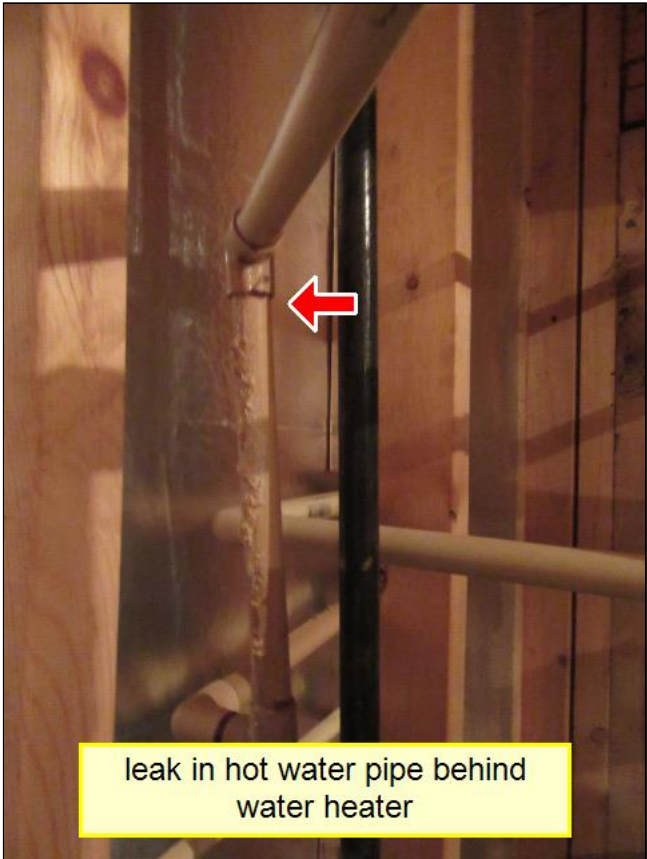
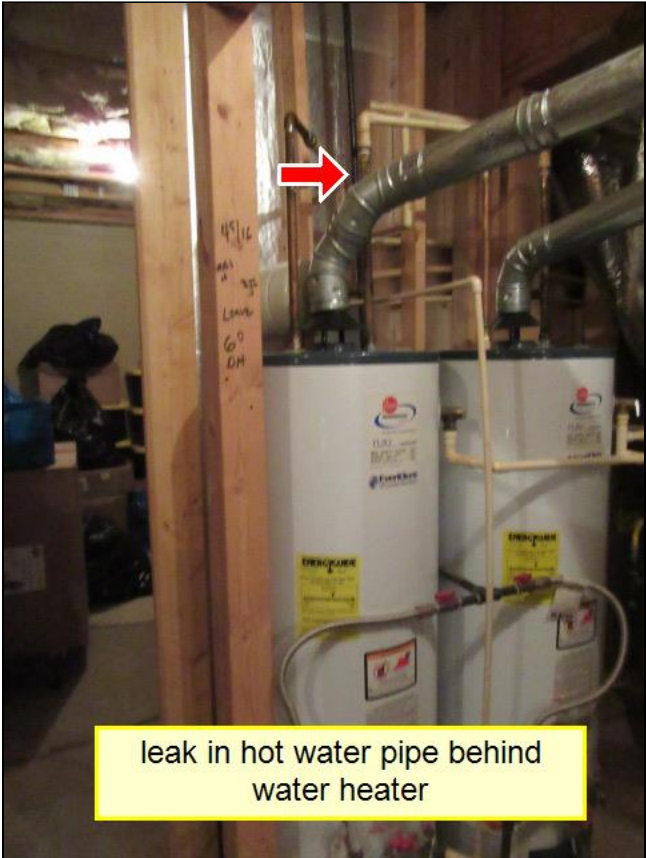
7.0 Item 1(Picture)

7.0 Leak in hot water pipe at rear of water heater was noted. Repair is needed by a qualified professional.

leak in hot water pipe behind water heater

Leak in hot water pipe at rear of water heater was noted. Repair is needed by a qualified professional.

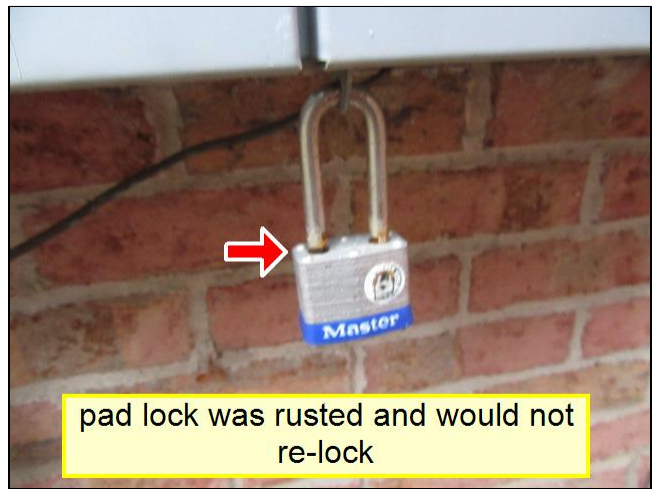
8.1 Item 1(Picture)

8.1 Pad lock on exterior disconnect panel was rusted, difficult to unlock and would not re-lock. Replace pad-lock as needed.

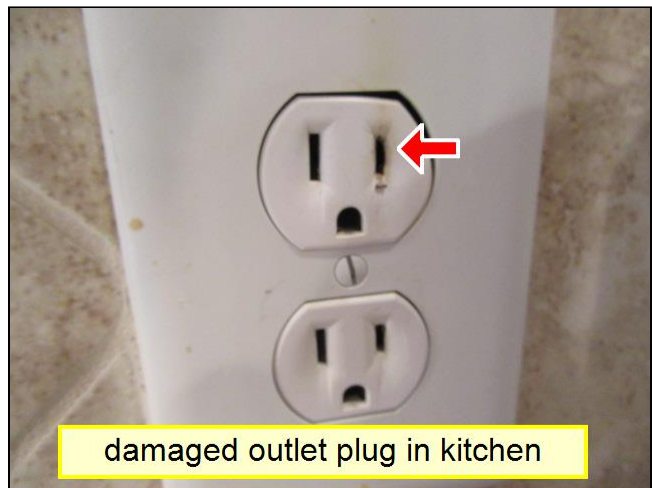
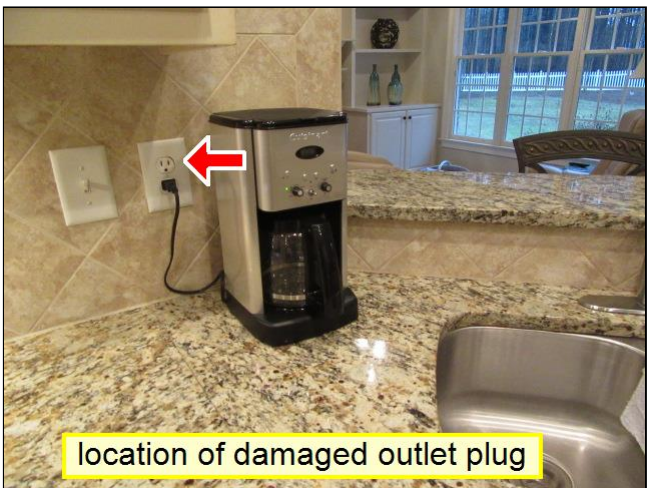
8.3 Item 1(Picture)

8.3 Damaged outlet plug was noted in main kitchen, adjacent to sink. Advise outlet be replaced.

Damaged outlet plug was noted in main kitchen, adjacent to sink. Advise outlet be replaced.

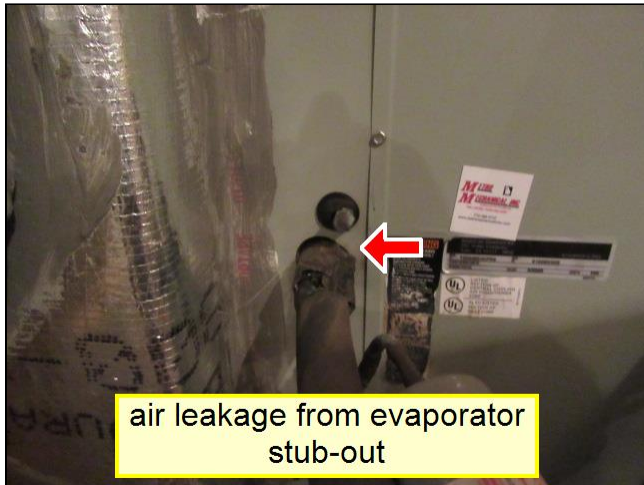
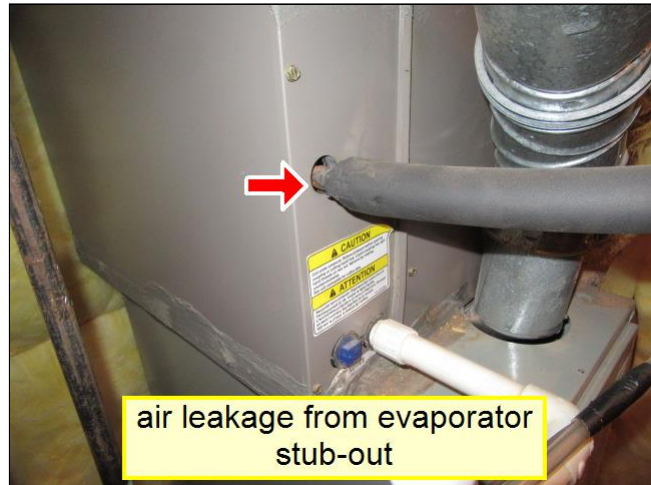
9.6 Item 1(Picture)

9.6 The air conditioning system(s) were not tested for proper operation due to the outside air temperature being 60 degrees or less. Recommend systems be serviced prior to use next cooling season.

Minor air leakage from evaporator stub-outs were noted at both systems in basement. Suggest air leaks be sealed for improved efficiency.

The air conditioning system(s) were not tested for proper operation due to the outside air temperature being 60 degrees or less. Recommend systems be serviced prior to use next cooling season.

Minor air leakage from evaporator stub-outs were noted at both systems in basement. Suggest air leaks be sealed for improved efficiency.

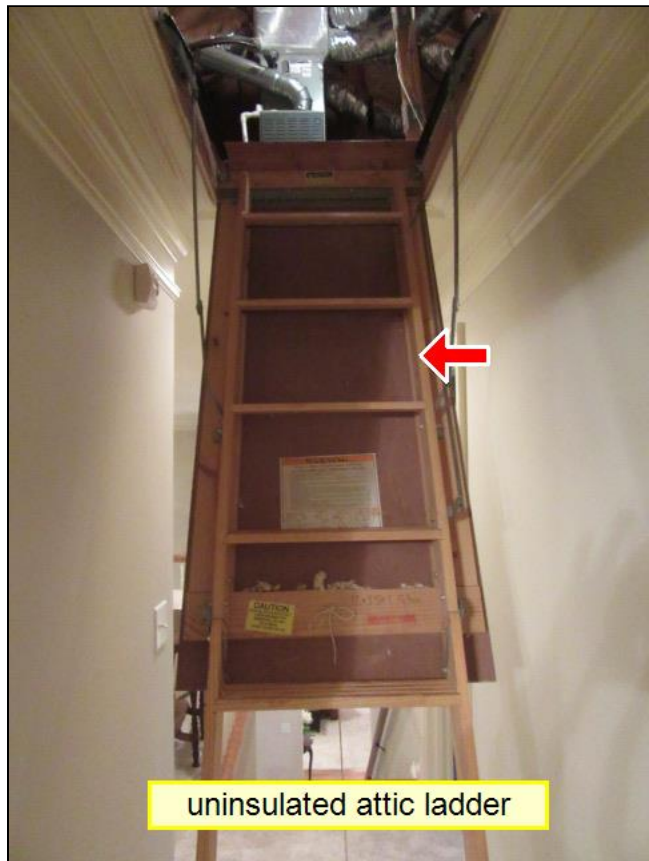
11.5 Item 1(Picture)

11.5 The attic ladder was not insulated. Recommend insulation and weather stripping be added for improved efficiency.

The attic ladder was not insulated. Recommend insulation and weather stripping be added for improved efficiency.
